Inspector's Daily Report

IDR Sheet	1	of	1	Sheets	Final Record Book	Page
Contract	C-7852			Day	Tuesday	
				Date	May 24, 2011

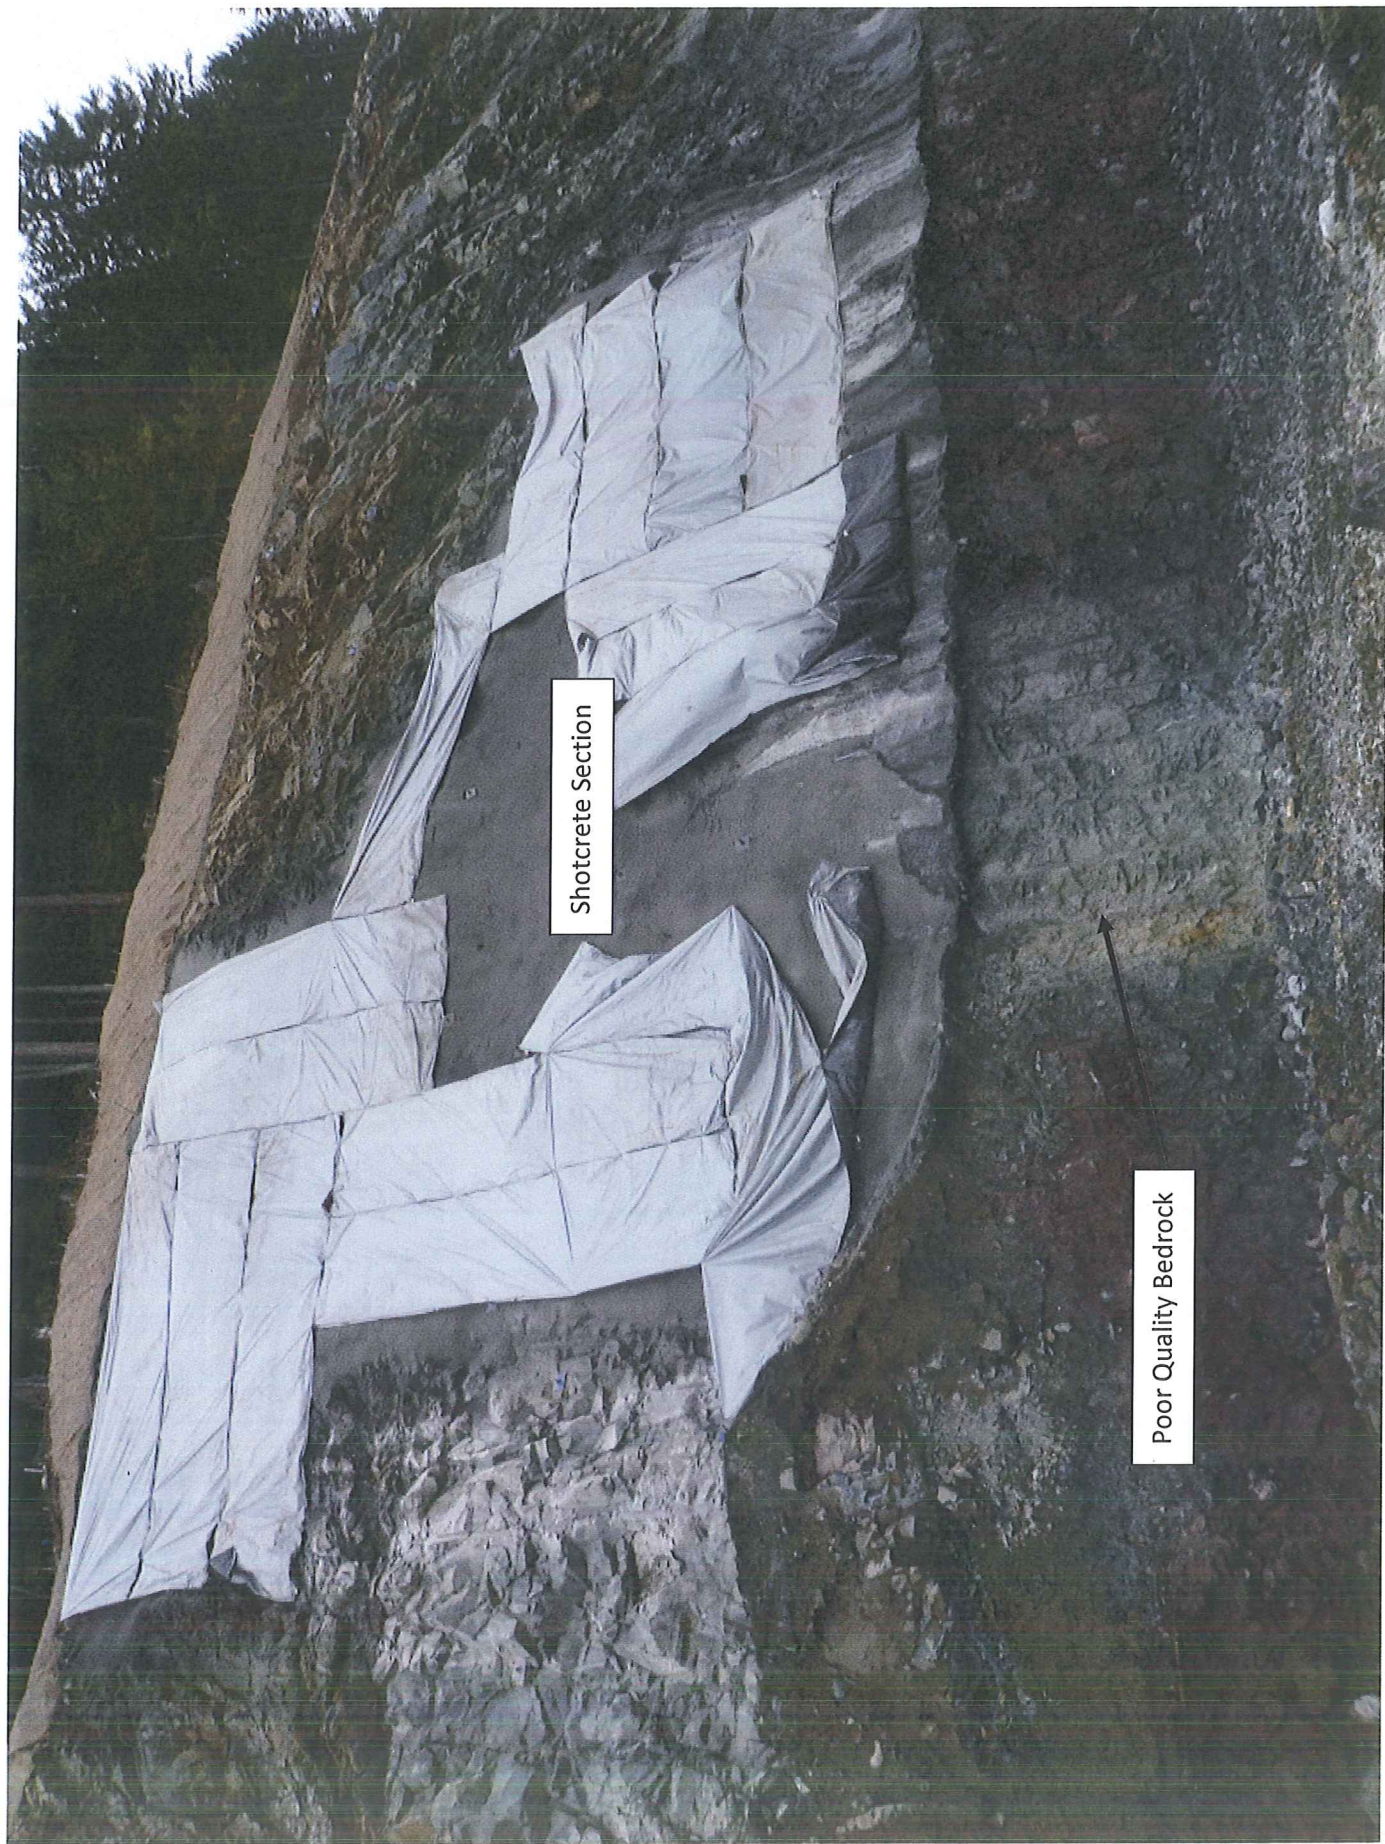
Figure 1. A photograph of the shotcrete section around station 1322+00. Note the poor quality bedrock located beneath the shotcrete.

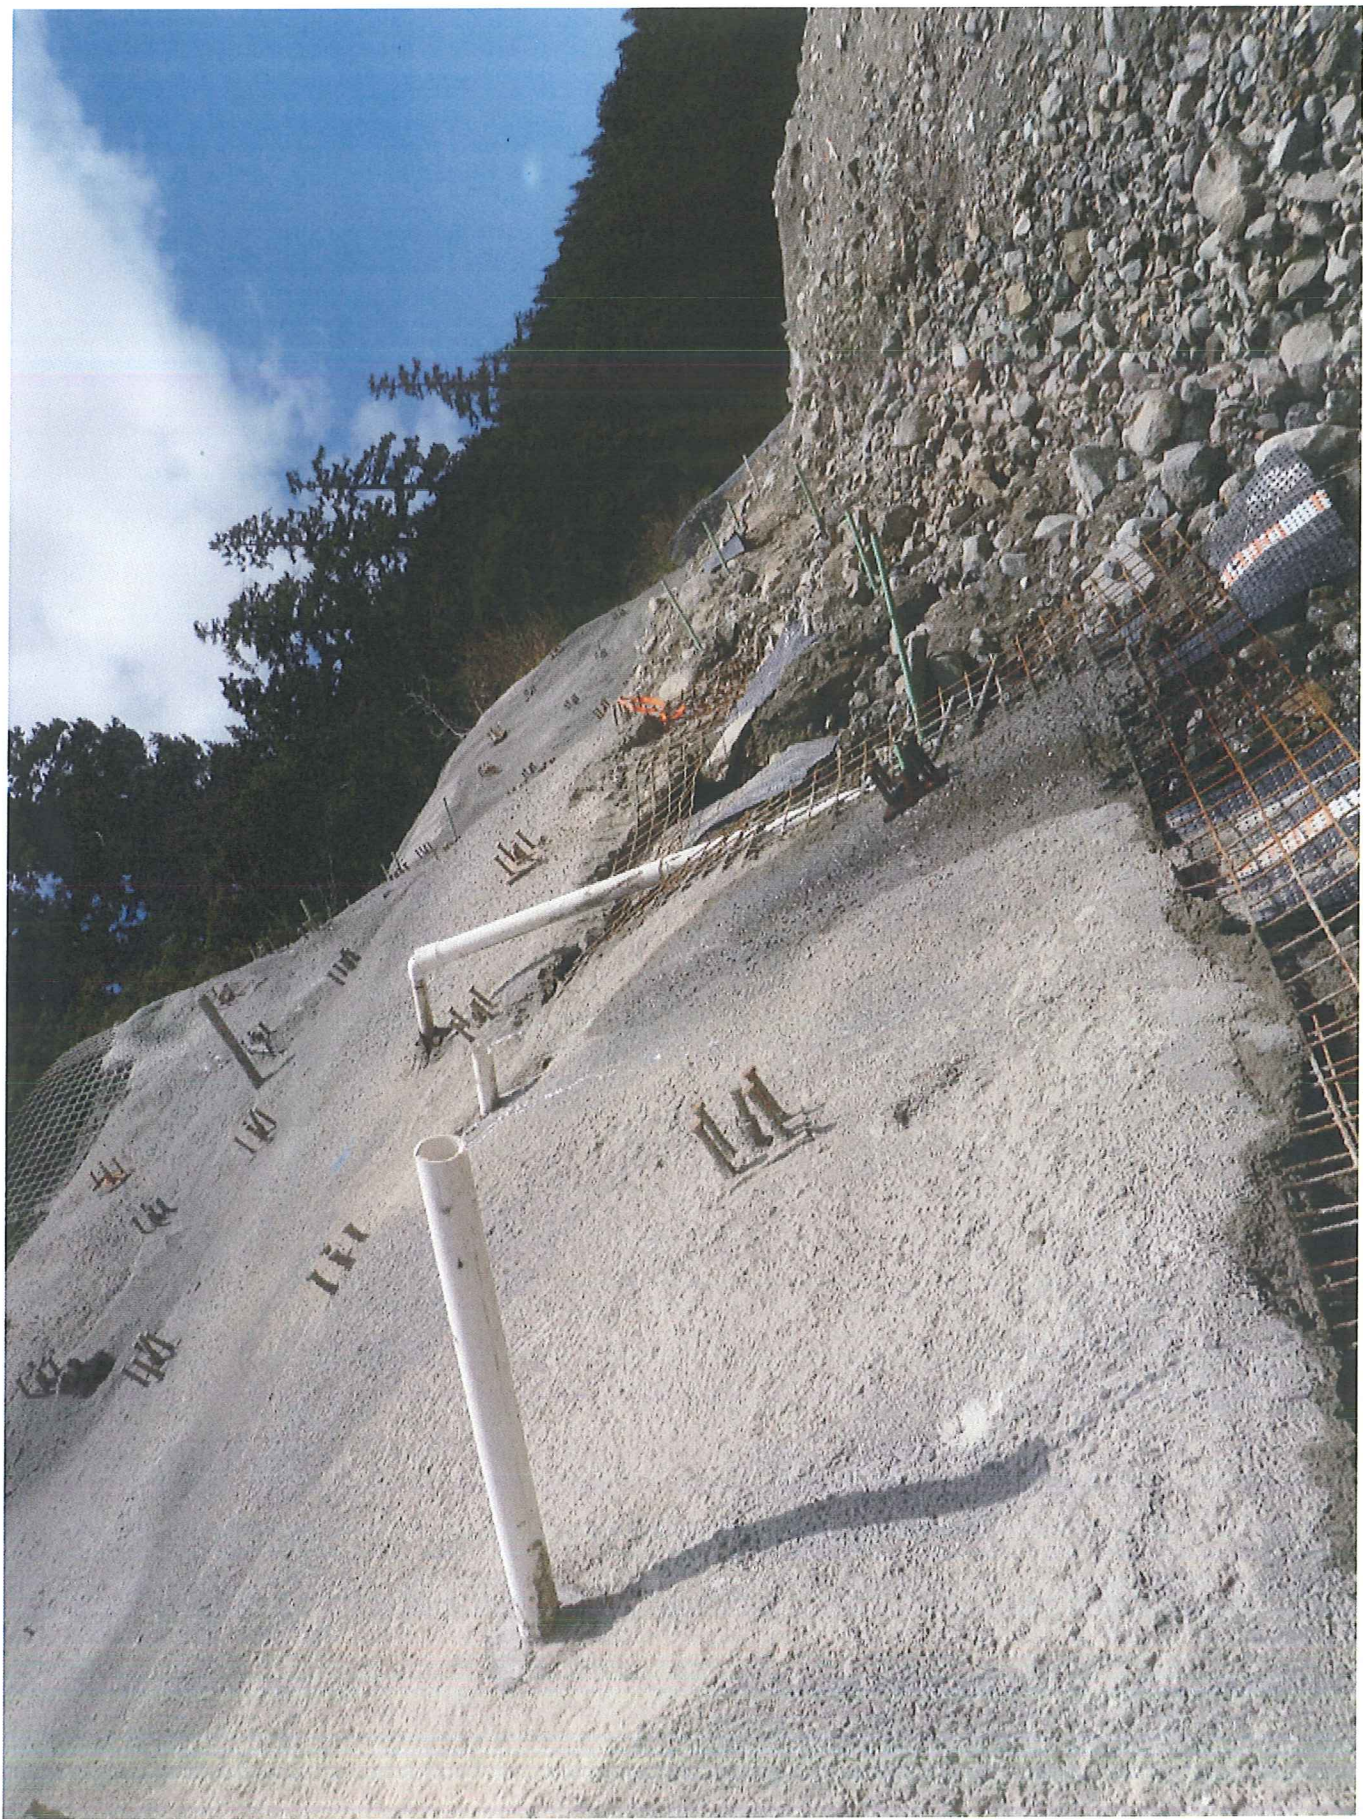
I drove to the east side of the project around 1:30 pm to take some photographs of the soil nail wall for the file. Sarah Davis (WSDOT Inspector) asked if the recently installed horizontal drains, located in the zone where the water was emitting from the slope, would be adequate. While we were on site, water was emitting from all three newly installed drains (Figure 2). I indicated that once the lift was excavated to the final elevation, we would revisit this area to determine if additional drains are needed.

Figure 2. A photograph of the three newly installed horizontal drains in the soil nail wall. Water was emitting from all three drains during our site visit.
